# Safety Briefing

July 2025

## Scaffold incident at London Liverpool Street Station

Ref: NRL25-03

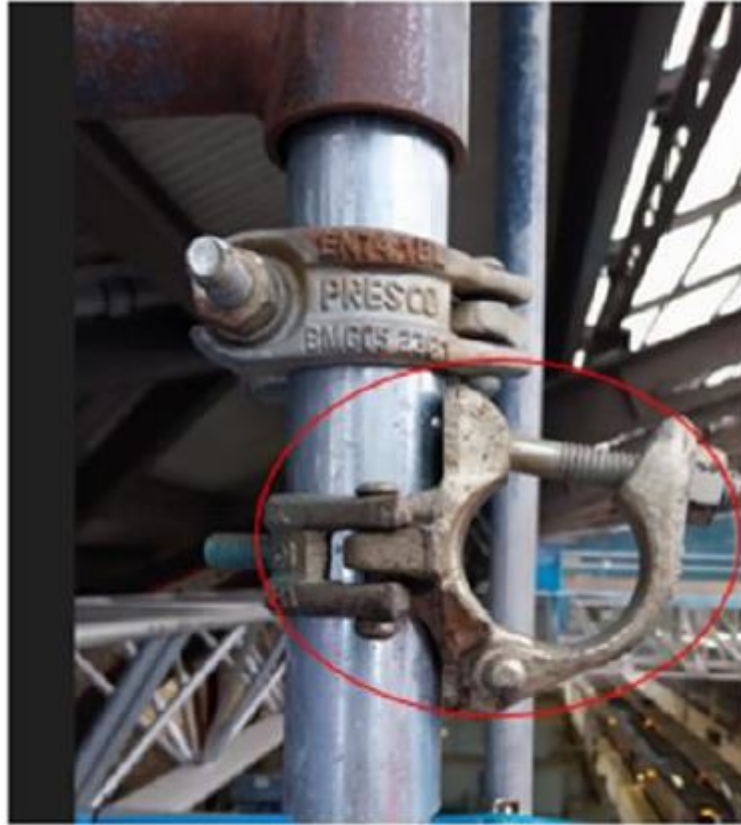
- The check coupler fell because it was not correctly tightened. The orientation of the check coupler prevented the scaffolder having visibility of the bolt head whilst tightening the fixing. This led to the bolt being insecure, and vibrations from ongoing work caused the coupler to loosen and fall.

*Bottom fitting was acting as supplementary coupler. Note: Not the actual fitting, this is a similar arrangement.*

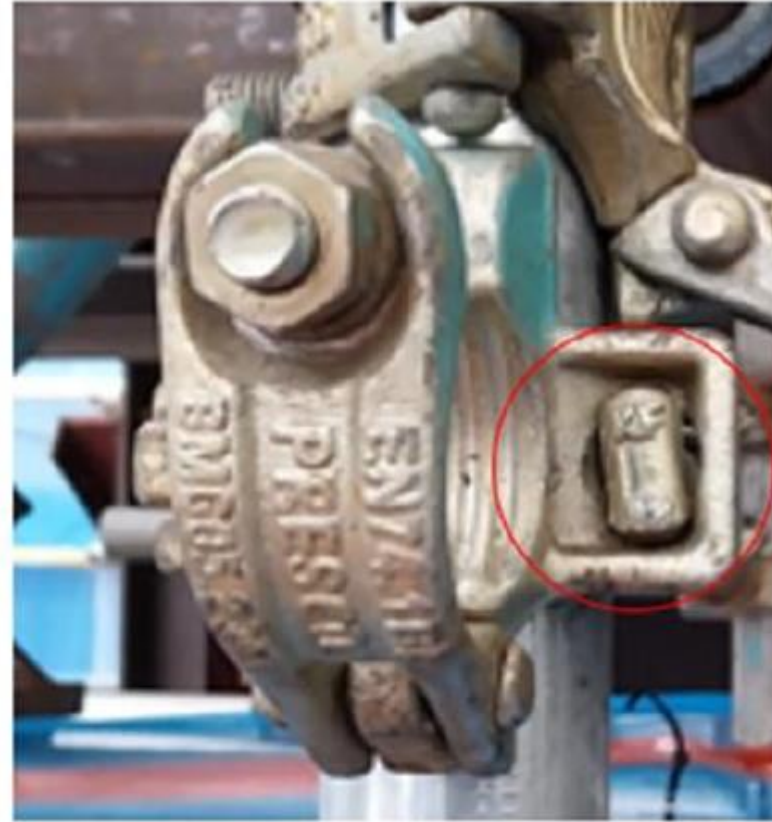
The investigation concluded that the coupler had not been correctly tightened and vibrated loose when the scaffolder was working on an adjacent fitting.

*Fitting showing how the bolt head should have been seated in the clip body correctly to prevent fitting becoming loose and falling.*

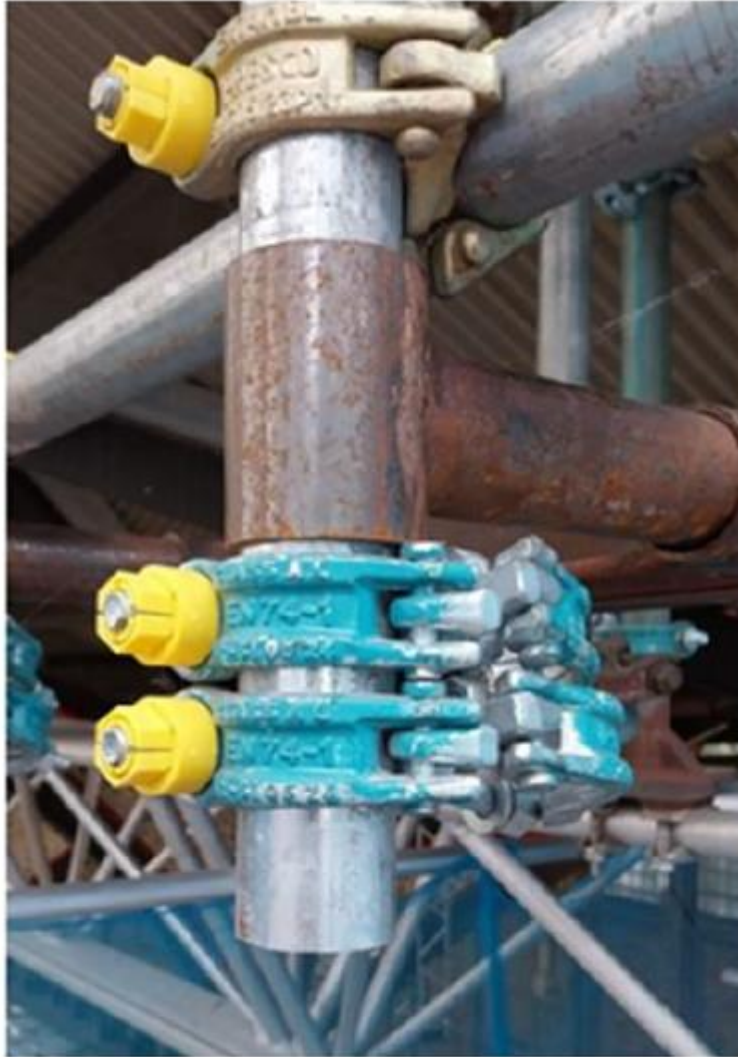
*Revised detail with swivel coupler fittings permitting visual inspection of both fittings by erector. Note: Yellow Klikon caps to aid inspection.*

- The design of scaffold should take account of installation restrictions and make sure components are selected that suitable for safe installation by those undertaking the works.
- Supervisors in charge of works should be provided with and briefed on the Work Package Plan and Task Briefing contents and ideally involved in their development.
- Specific risk controls detailed in the Work Package Plan should be incorporated into the Task Briefing Sheet to make sure that the correct level of detail is delivered through briefing to those undertaking the works.
- Principal Contractors to review their assurance procedures and processes to assure that Contractors/Sub-Contractors are working in accordance with defined methodology and designs/specifications.

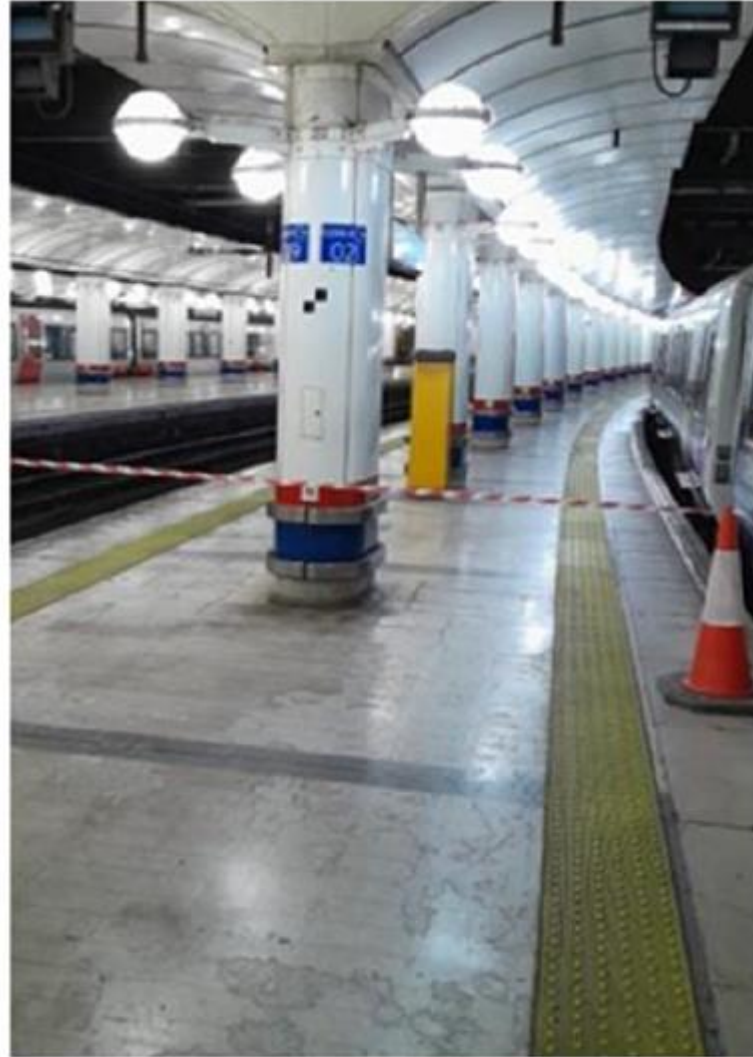
The coupler landed within an exclusion zone that had been established on the station platform, resulting in no injuries or damage.

*Exclusion zone in place during the scaffold works.*

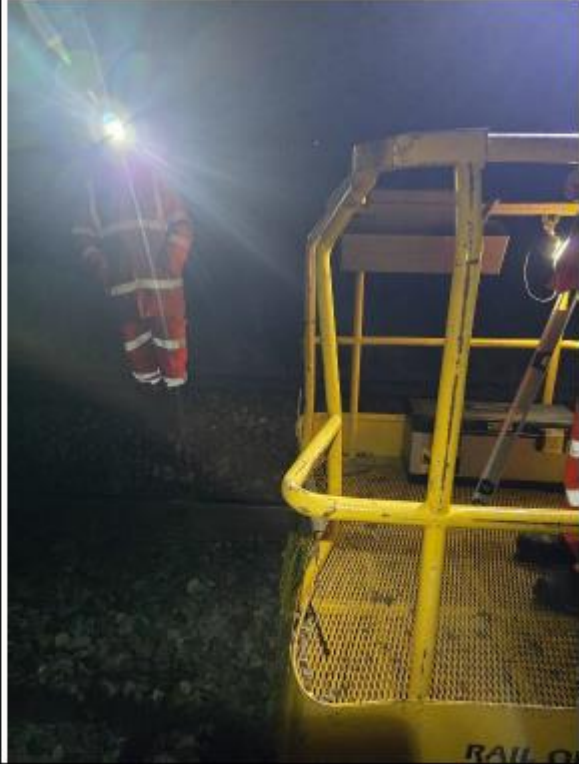
| Incident – Mewp Collision | |
|---|---|
| <p>On 02/06/2025 @23.40hrs, 2 X MEWPS were undertaking OLE SPS installation on the Rhymney Single line @ 19-mile 10ch.</p> <p>The Mewps were working basket to basket, Mewp No 7 was low mileage and Mewp No 8 was high. Mewp No 8 had his basket spun 360% to allow him to assist with the SPS installation. Once the works were completed Mewp No 8 went to travel back and the operator of Mewp No 8 went forward instead of back which caused the 2 baskets to collide causing damage to the basket of Mewp No 7.</p> <p>Incident reported to:</p> <ul style="list-style-type: none"><li>• ES</li><li>• CVL Level 3 Oncall</li><li>• DCM - Incident log#: 3066540</li></ul> | |

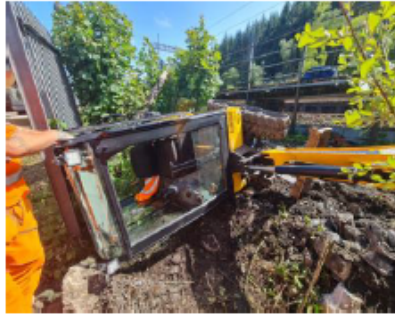
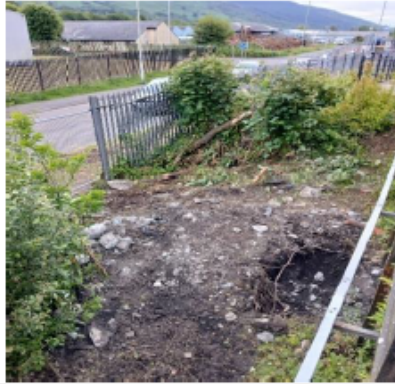
| Personnel Incident / Accident | |
|---|---|
| <p>Mini excavator(1.5t) fell over onto its side while working in the area between the back of the Downside elevated platform and the palisade boundary fence behind the DN platform.</p> <p>The 1.5t excavator was involved in breaking out old concrete light column foundations at the rear of the DN platform.</p> <p>The excavator had just repositioned itself on the south side of the excavation after initially working on the northern side of the excavation. The excavator was sat on uneven ground /arising from the excavation. During the excavation activity the excavator overturned in slow motion onto its right hand side.</p> <p>The driver was wearing his seatbelt and was uninjured. Minor damage (slight denting to engine cover door and scratch) was caused to the excavator. The excavator has been assessed by a fitter and confirmed to be fit to use.</p> <p>Within an hour of the incident occurring it was reported to the AGC PM and Operations Manager, the AGC SHEQ department and the AIW/TfW PM.</p> <p>This incident is <b>not</b> reportable under RIDDOR due to; no-one being injured as a result of this incident and no harm could be caused to others as a result of this incident due to the exclusion zone in place.</p> <p>Prior to recommencing this activity the type/suitability of plant and methodology will be re-assessed.</p> <p>The operator and banksman have undertake for cause D&amp;A testing. Both returning a negative result.</p> | |

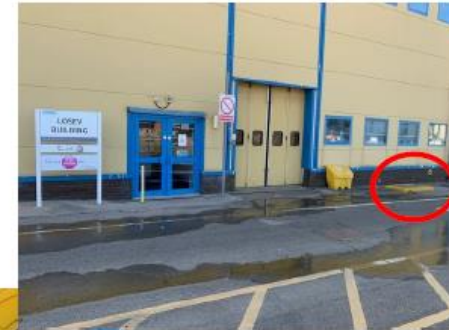
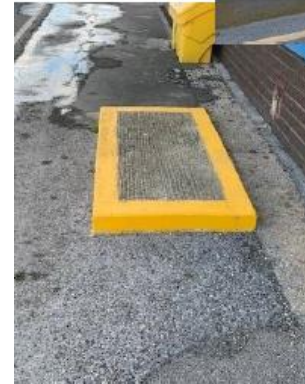
Whilst walking past the Losev building, they tripped over the edge of an unused concrete plinth (1550[L] x 760mm[W] x 90[H]) and fell to the floor. This resulted in their left shoulder feeling stiff and uncomfortable, and they were correctly advised to go home to recover.

Photos taken at  
time of accident  
showing the  
concrete plinth
