Safety Briefing

May 2024

Monthly topics

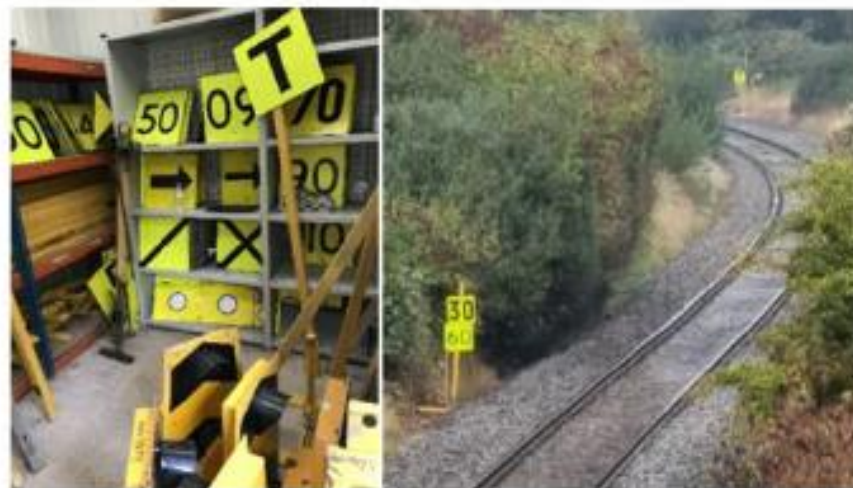
There were several serious and concerning incidents during 2023, involving Emergency Speed Restrictions (ESRs) and Temporary Speed Restrictions (TSRs). Although the causal factors for each incident were slightly different, the common element was a failure to fully install and implement the speed restriction. These have led to unsafe situations with trains overspeed across the defect and the subsequent response caused unnecessary disruption to railway operations and our passengers. These incidents have also resulted in the maintenance teams accessing the infrastructure to inspect the positioning of the signage.

This incident was where an implemented ESR did not have a magnet installed. This led to the train being withdrawn from service for an inspection, disrupting service and causing a safety hazard to the railway operation.

Due to human error when reinstating back to the original TSR, the Permanent Way team forgot to reinstall the AWS magnet.

This incident happened where a 20 mph ESR was erected due to hot weather precautions. There was an existing 20mph ESR in place on the Down Slow 2 line, with associated warning equipment already installed on the Down Fast from where it could be accessed.

It was realised post implementation of the speed on the 11th of June, that the order of the warning equipment was incorrect as staff had added the warning equipment for the Down Fast 20mph ESR beyond the pre-existing warning equipment for the Down Slow 2 (with directional arrow) 20mph ESR.

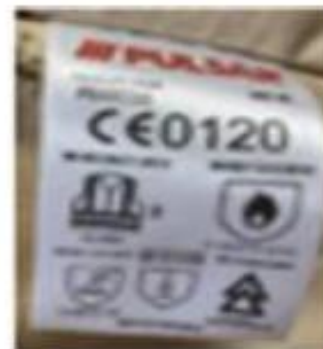
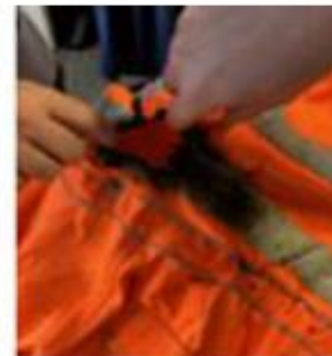
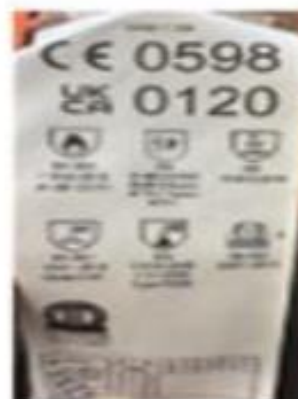
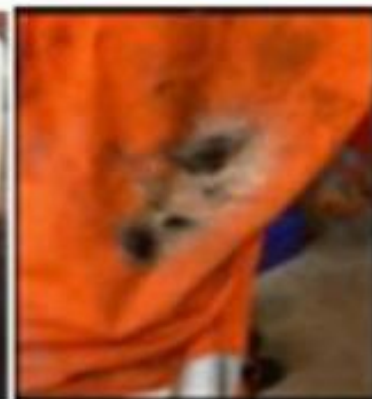
Following examination of some NR supplied welding and grinding PPE garments it was found they did not meet the approved specifications for NR staff conducting these activities.

Investigations found that some garments were marked ARC Flash PPE and being used for welding activities.

Investigations identified that incorrect PPE for welding/grinding had been mistakenly ordered through the Punchout system and staff had received ARC Flash Protective Garments not welding specific.

- All Staff in the Welding and Grinding community must order and purchase garments that are approved for use for NR Staff by the PPE Governance Panel. Use the C&P Punchout system when ordering.
- Only approved PPE obtained through the NR Procurement System will conform to all the specifications, and sub-categories, required for the different types of Welding carried out within Network Rail.
- PPE that has not been approved by the PPE Governance panel may not meet all the specifications required and could cause harm to the wearer.

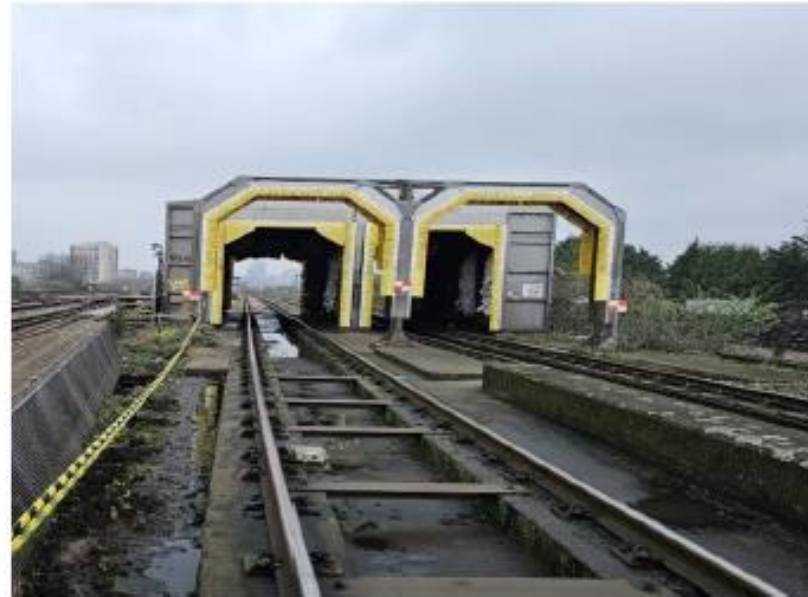
A serious accident involving a contractor working for South Western Railway occurred on Monday 11th March 2024 in the carriage wash area at Clapham depot.

The contractor was undertaking maintenance activities and was fitting low-level overspray brushes onto the carriage wash. The injured person (IP) was standing on a wooden infill adjacent to the bridge parapet. While using the structure of the bridge as a workbench, the infill gave way causing them to fall through and land approximately 20 feet below onto another railway line (which is operated by a different route/control (which was operational at the time.

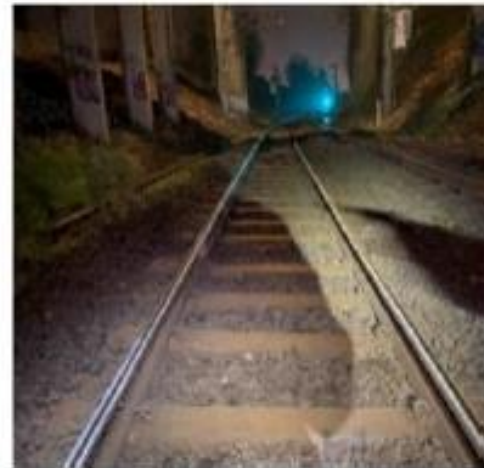
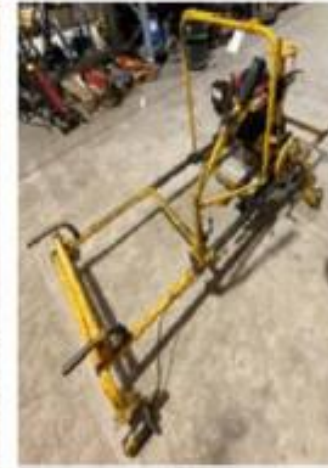
At 02:31 on Wednesday 6th March 2024, a Welding & Grinding team were carrying out profiling of a rail head in a possession between Gravelly Hill and Lichfield Trent Valley. During the work activity the team lost control of the Rail Grinder, the machine travelled up a gradient initially and then onwards for approximately 4 miles uncontrolled before coming to a stop.

The machine has been quarantined and sent for testing to analyse whether mechanical failure could have been an underlying cause.

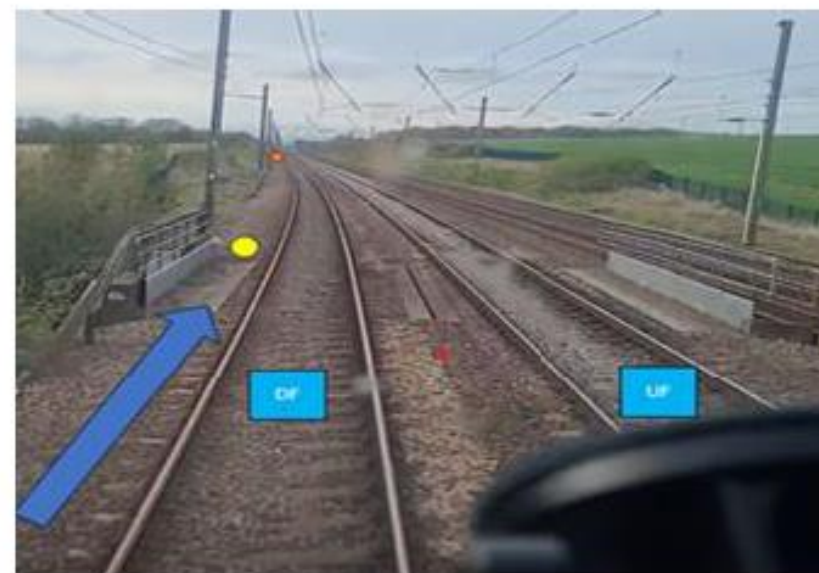
On 23rd April 2024 in the Chiltern Green area, Luton, ELR: SPC1, at approximately 09.50, a trackworker (a Telecomms Tester) was walking in the Down Fast (DF) Cess to return to their work group after leaving them to use the welfare at the original access point. All lines were open to traffic.

As part of the route back the trackworker approached and subsequently proceeded to cross limited clearance U/B 127. At which time a train on the DF approaching the bridge sounded their horn and applied its emergency brakes, as the driver of the train believed they were at risk of striking the individual.

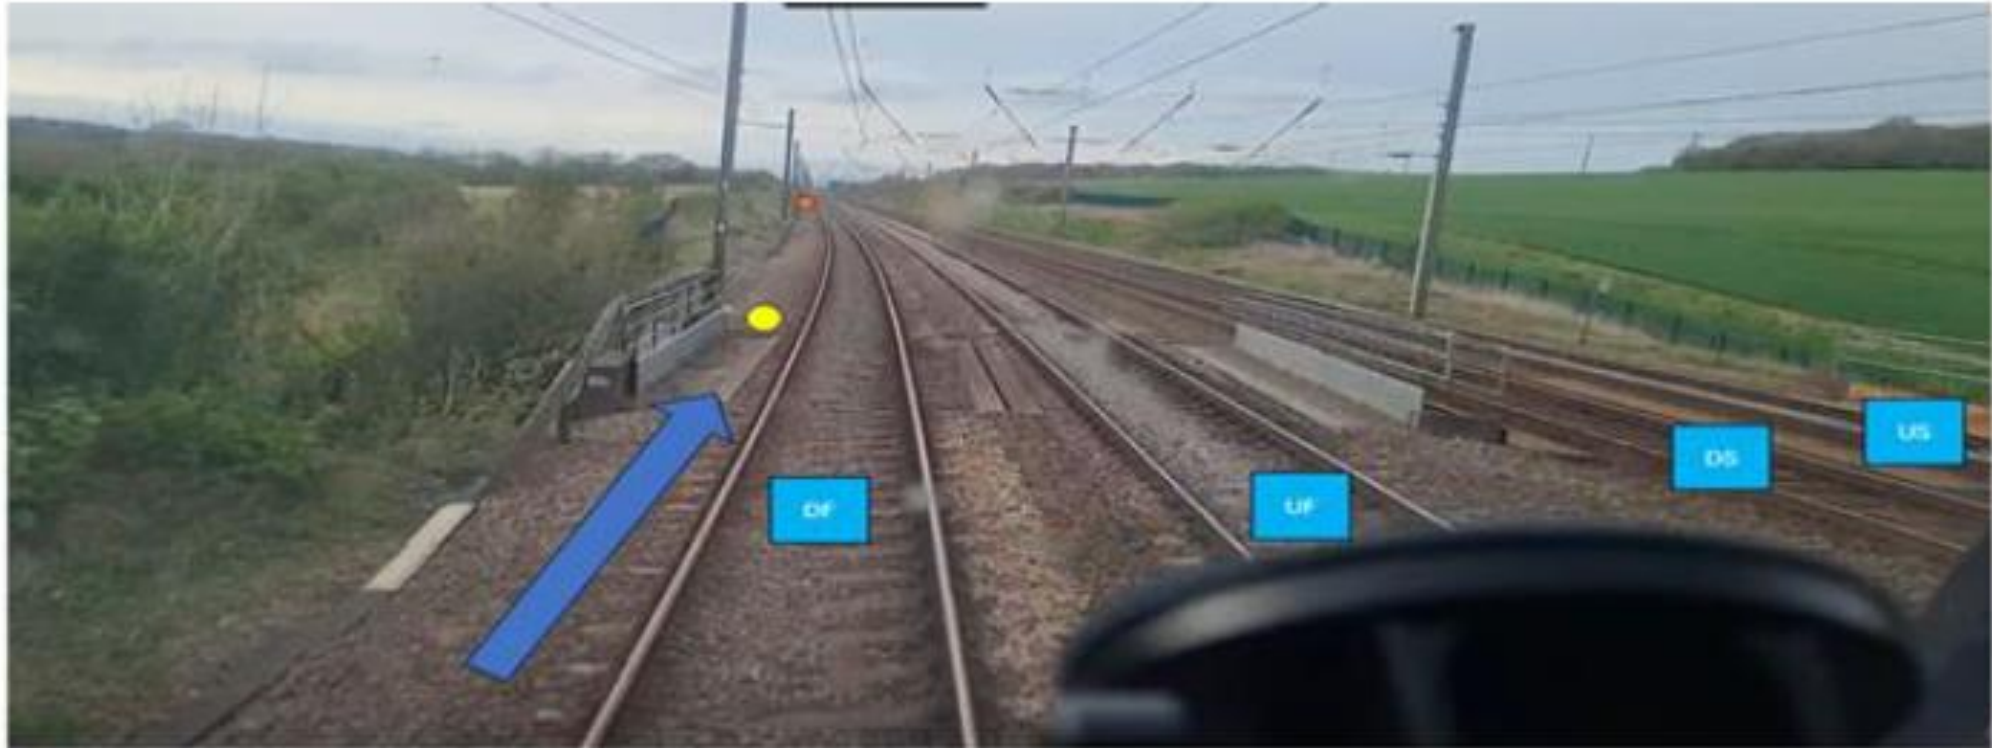
● Position of Tester1 – Near Miss location.

● Group Position (Site Work)

➔ Direction of travel by tester1 (walking towards the group away from the access point)

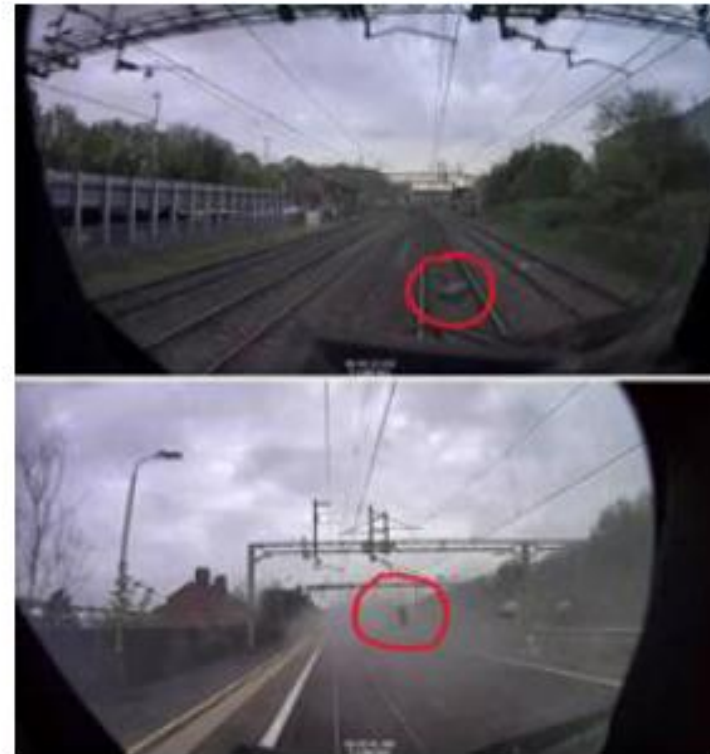
On the 25th of April 2024, the first Avanti West Coast service travelling at line speed on the Up Fast line through Kings Langley struck a piece of temporary RRAP which had been left in the four-foot following emergency OHL repairs during the night. A second train travelling on the adjacent line (Down Fast line) also suffered a cracked windscreen from the impact of the temporary RRAP. There was no one injured, however if there were people on platform it would have caused serious injury or a worst case fatality. This led to significant disruption / cancellations on the West Coast South route.

Initial investigation found that site lighting was not adequate and a reliance was on head torches. There was no system in place to count out and count in the RRAP pieces (approximately 20 pieces in this instance). Although the PIC stated they were not fatigued, they had a busy day before coming into work at night.
