Rail Safety Briefing
October

Monthly Topics

Rail skate struck by train

Aspen Hi-Flow Condensate Pump Burn Out

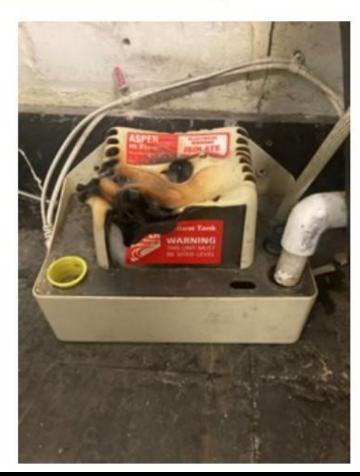
The Fire Service arrived on site at 12:04 and determined that the source of the smoke had self-extinguished prior to their arrival. The origin of the incident was identified as the Aspen Hi-Flow Condensate Pump, as depicted in the attached photograph. No other equipment within the room sustained damage as a result of heat or smoke. Notably, no fire suppression systems or water-based extinguishing methods were required or deployed. As a precautionary measure, the Fire Service isolated the air conditioning unit and disconnected the pump from its power supply.

The precise cause of the pump failure remains under investigation. The unit has been inspected and returned to the manufacturer for detailed analysis. Further updates will be provided as additional information becomes available. The pump underwent its most recent scheduled maintenance in May 2025, at which time it was assessed to be in satisfactory working condition.

- Are the scheduled maintenance activities for air-conditioning units and condensate pumps being undertaken to the correct frequency?
- Do high demand or older systems require more regular maintenance activities?

- Do maintenance activities include regular cleaning to the filters and drain lines to prevent clogs?
- Are the units installed according to the manufacturer's instructions?
