# Safety Briefing

July 2025

## Scaffold incident at London Liverpool Street Station

Ref: NRL25-03

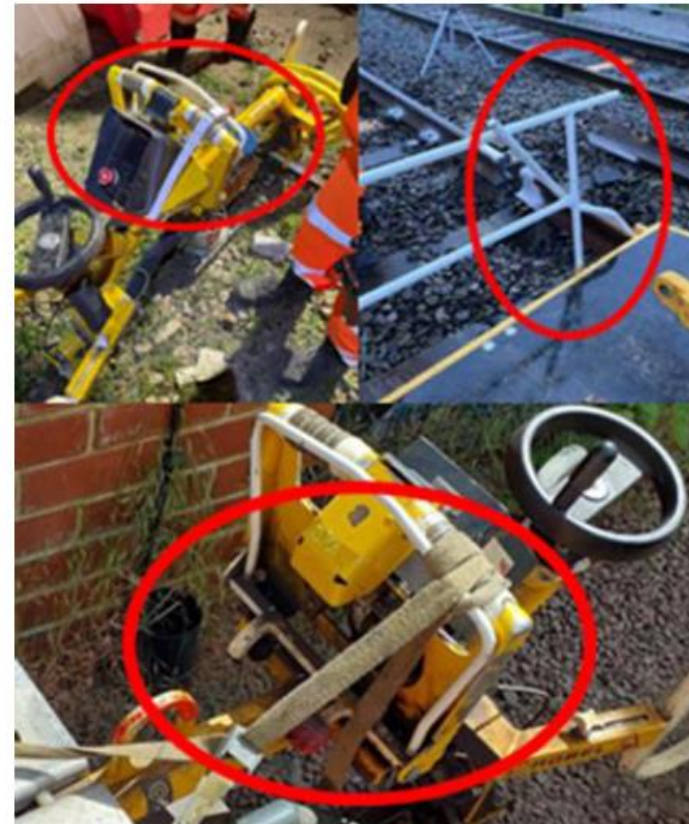
There has been several instances over the last two years where braking systems fitted to Manually Propelled Trolley (MPT) and Grinding Equipment have been tampered with thus making the braking systems ineffective. This activity increases the risk of runaway, possible injury to staff if struck by MPT and damage to equipment.

Operators of these equipment types are reminded that interfering with safety system such as brakes can lead to you or your colleagues being injured or killed; this is a breach of Network Rails Life Saving rules.

These practices also contravene NR/L2/RMVP/0200 P514 paragraph 3.3.2 “Do not adjust or interfere with the braking mechanism of a trolley” The practice of interfering with such systems should cease with immediate effect. If these systems are identified as faulty, then the equipment should be immediately removed and quarantined.

There will be increased surveillance activities around the use of these equipment types.

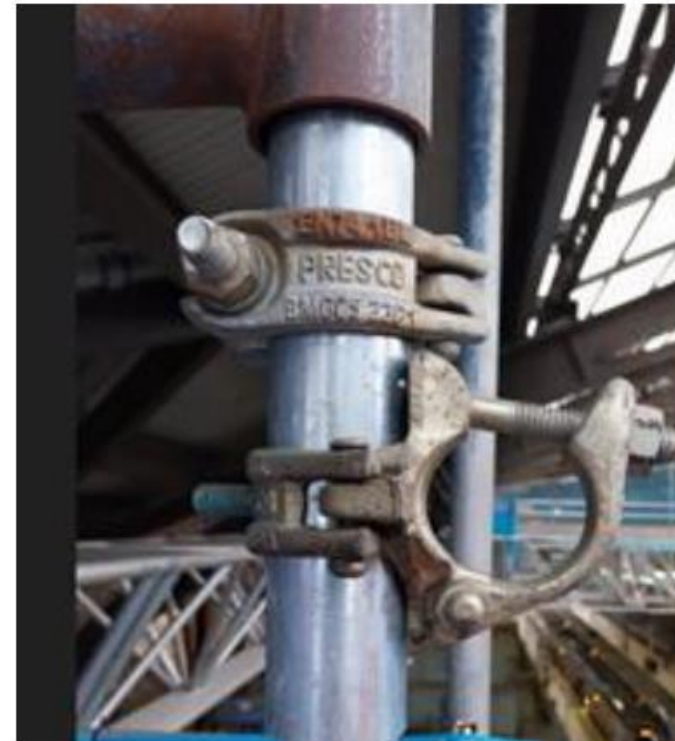
During the installation of a tube and fitting hanger for a suspended scaffold, a supplementary check coupler fell approximately 15 metres onto one of the station platforms.

The coupler landed within an exclusion zone that had been established on the station platform, resulting in no injuries or damage.

The investigation concluded that the coupler had not been correctly tightened and vibrated loose when the scaffolder was working on an adjacent fitting.

- The check coupler fell because it was not correctly tightened. The orientation of the check coupler prevented the scaffolder having visibility of the bolt head whilst tightening the fixing. This led to the bolt being insecure, and vibrations from ongoing work caused the coupler to loosen and fall.
